NACA RM A53F23

THE EFFECTS OF FENCES ON THE HIGH-SPEED LONGITUDINAL
STABILITY OF A SWEEPED-WING AIRPLANE

By Richard S. Bray

Ames Aeronautical Laboratory
Moffett Field, Calif.

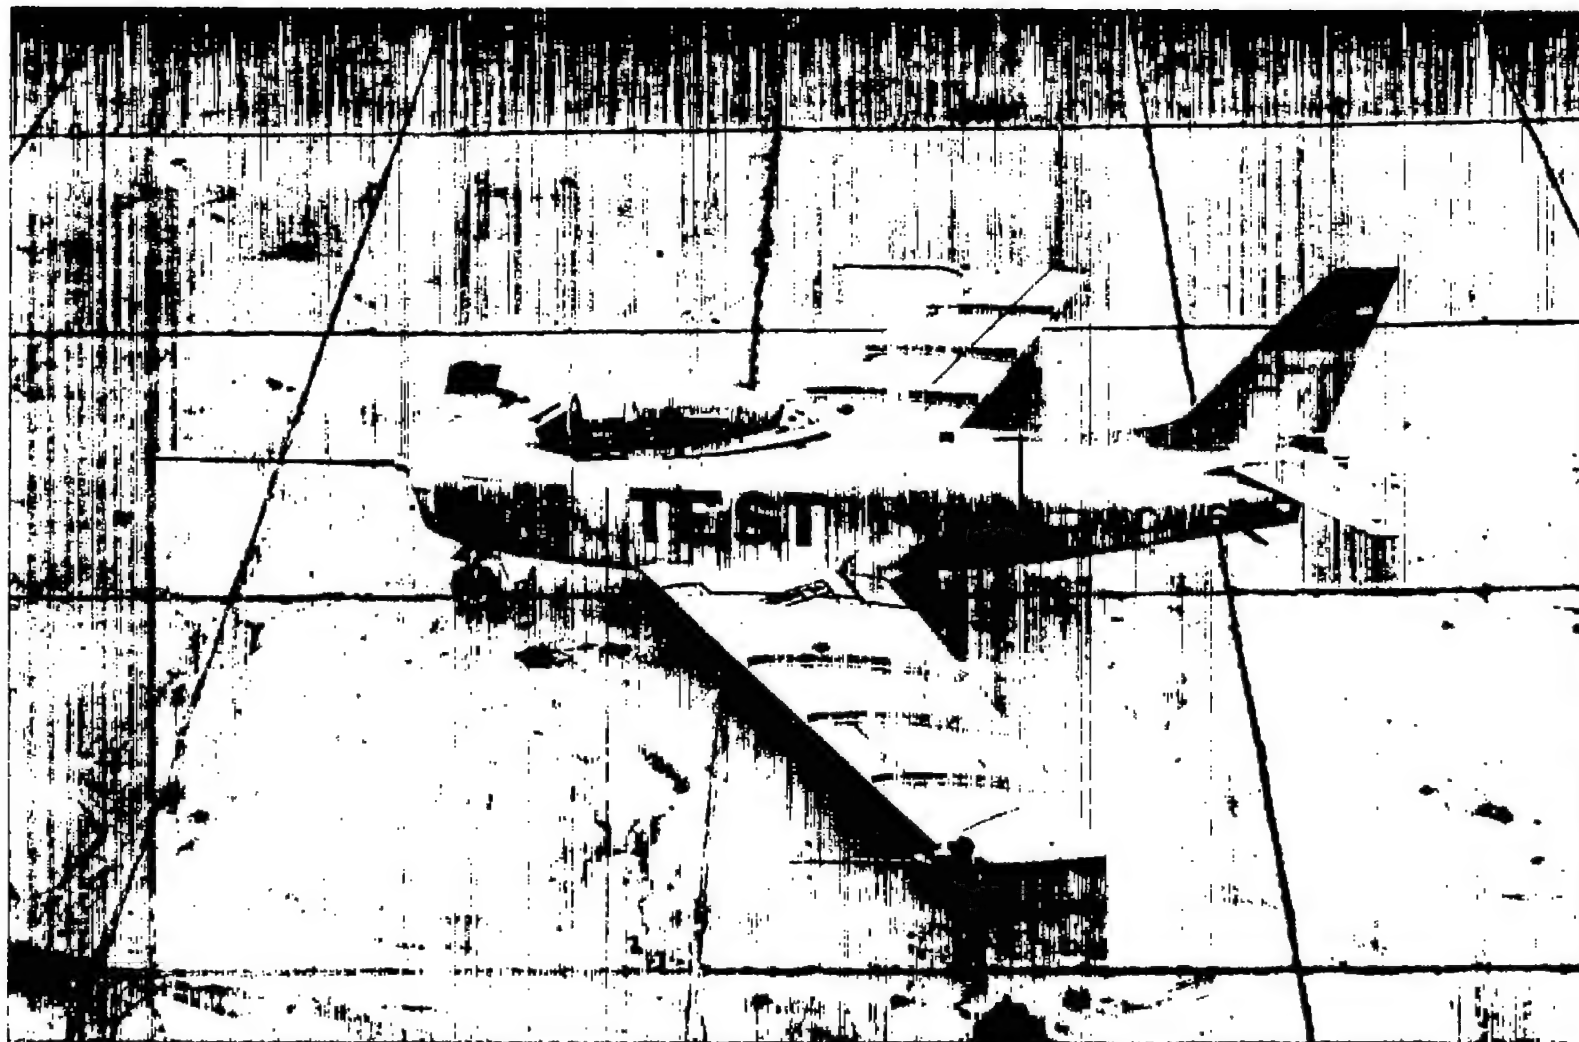
Figure 3.- Fence configuration A.

(b) Detail.
Figure 3.- Concluded.

The investigation included tests of the airplane unmodified and with nine individual fence configurations shown in table II. Five of these, configurations A through E, employed a multiple installation (three fences on each wing) and varied in chordwise extent. The fence locations were at 46, 63, and 80 percent of the wing semispan. Each of the fences of configuration A was tested individually to determine the effect of spanwise location. These configurations are designated A₁, A₂, and A₃. One additional installation, configuration F, simulated that in use on the MIG-15 airplane. Photographs of a typical fence installation are shown in figure 3, and geometric details of the basic fence configurations are presented in figure 4.
